### PROJECT ASSESSMENT

#### *“Shot-crete Job Gone Wrong”*

### RENOVATION PLAN

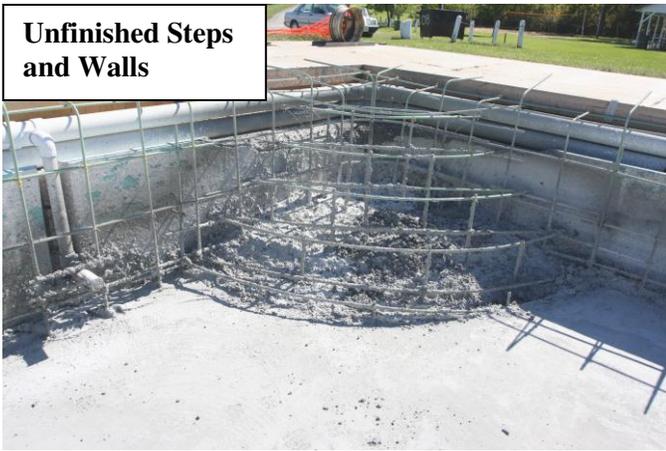
**Unfinished Steps and Walls**

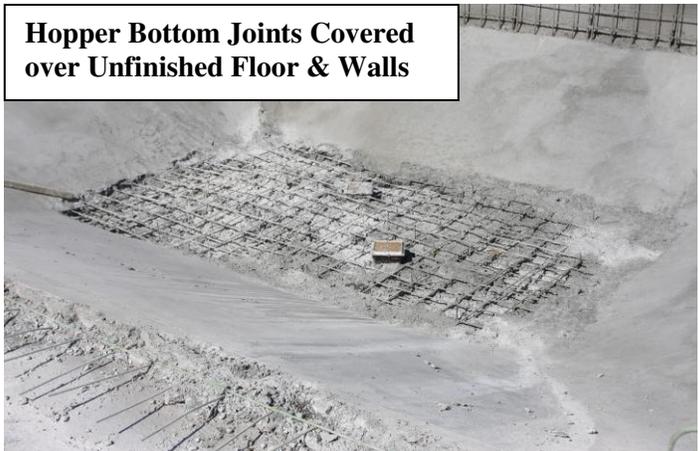
**Hopper Bottom Joints Covered over Unfinished Floor & Walls**

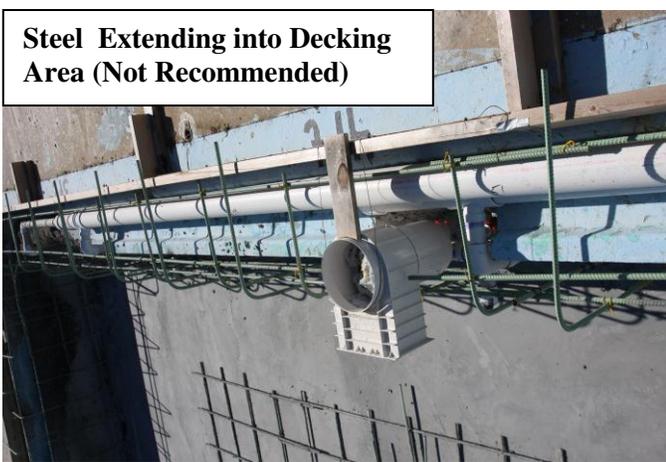
**Steel Extending into Decking Area (Not Recommended)**
