## PROJECT HISTORY

### BARLOW MOUNTAIN SCHOOL GUTTER RESTORATION

RIDGEFIELD, CONNECTICUT

COMPLETION: 2010

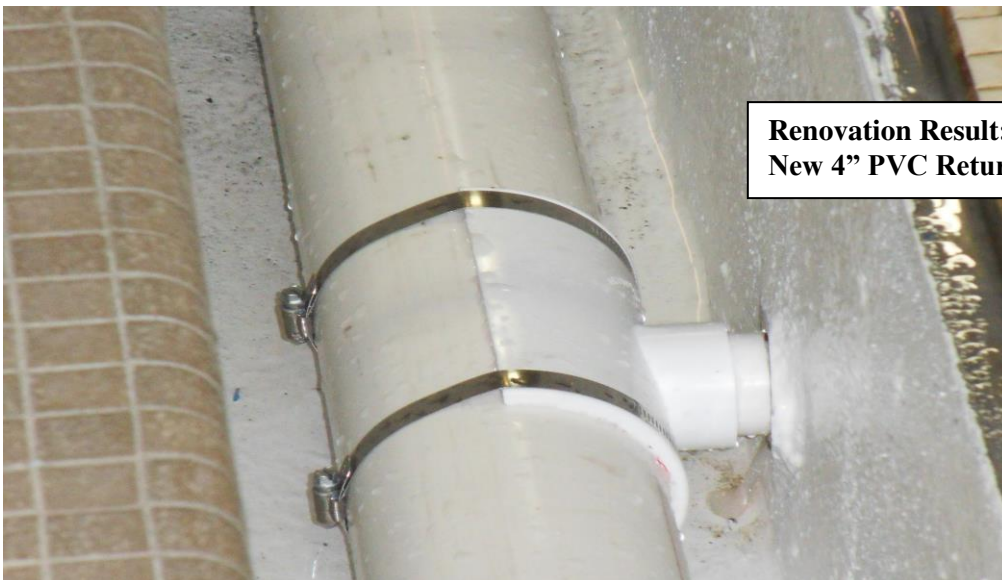
**Renovation Result: Gutter Channel Re-surfaced  
New 4" PVC Return Piping In Place**

Mid-America Pool Renovation, Inc. specified a wastewater materials repair system to perform the Work. This materials system included a microsilica cement mortar, a penetrating epoxy primer, and an ultra high build epoxy coating. The surface was cleaned, ground, and given a 6,000 psi water jetting with a rotational nozzle. Rust was cleaned off of all the exposed reinforcement steel and covered with Sika Armatec® 110. The channel was then re-surfaced with solvent free, high solids Epoxy Amine coating.
