PROJECT ASSESSMENT

HOLIDAY INN - MIDTOWN

GRAND ISLAND, NEBRASKA

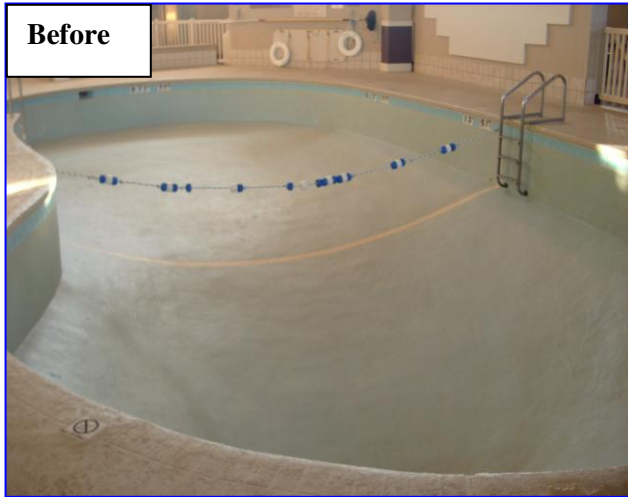
Before

Remodeling and renovating this large, holodomed pool set in the middle of an operating hotel required specialized attention. Past, repeated pool paintings did not solve the pool’s yellowing stained appearance. Each new layer of pool paint continued to blister and chalk. The existing waterline tiling was old and out of date, and safety markings such as depth and step demarcation were lacking.

Abrasive blasting was required to remove layers of blistering and peeling pool paint. Set just yards away from an operating restaurant, the entire pool setting required tarping before any work began. Ventilation units and tubing were set up for air circulation and to remove any residual fumes and dust out from the hotel.

The existing tiling was mechanically removed. Following abrasive blasting, high pressure water blasting (>5000 psi), and new tile installation, the INTER-GLASS® Reinforced Composite System was installed over the entire remaining pool interior surface.
