**PROJECT ASSESSMENT**  
*“What needed to be done”*

# CITY OF BURLINGAME, KANSAS

## BURLINGAME, KANSAS

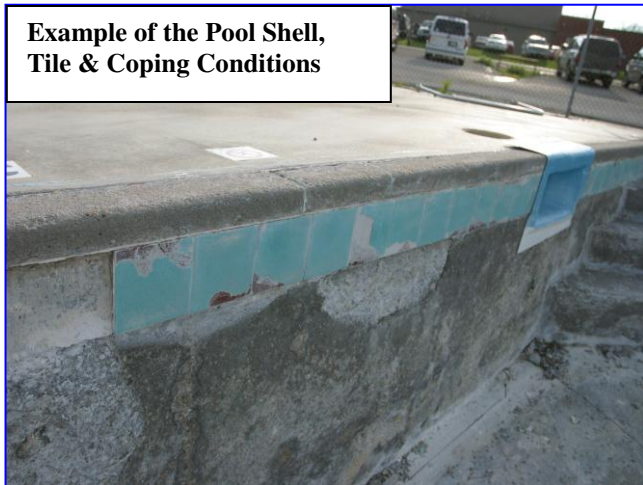
This large, formed and poured commercial pool was in need of complete re-construction. The entire pool interior including the expansion joints and waterline tiling was covered with a spray applied fiberglass liner only a couple of seasons before our work began. With no room for expansion or contraction, and a poorly prepared substrate, the liner began to release pulling off chunks of freeze damaged sub-surface concrete along with it. The pool coping was badly deteriorated and releasing from the bond beam at numerous locations around the perimeter of the pool.
