PROJECT ASSESSMENT
“What needed to be done”

FOREST LAKE HOMEOWNERS ASSOCIATION
LINCOLN, NEBRASKA

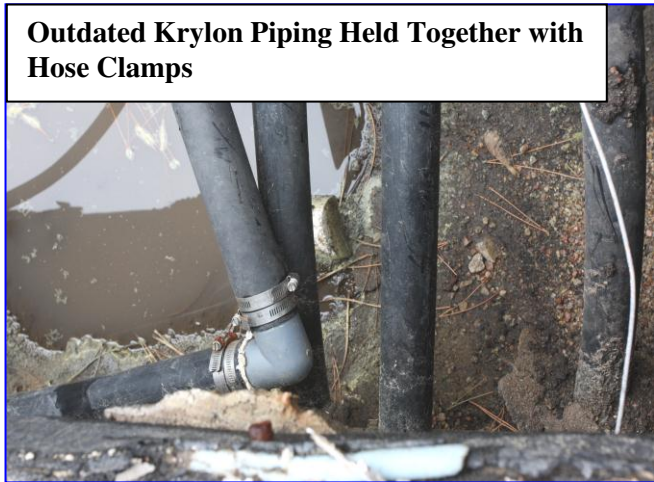
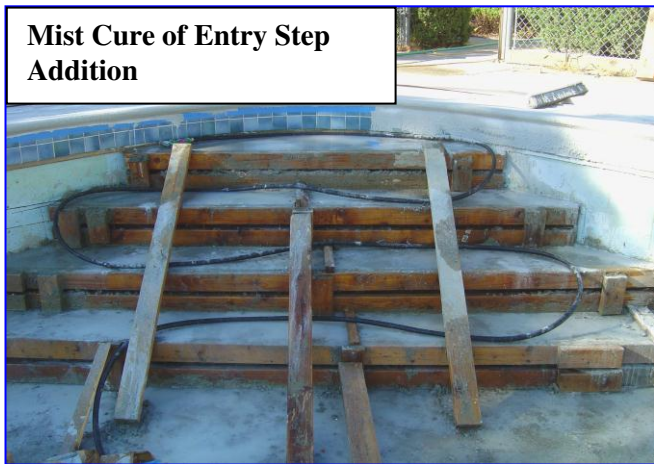
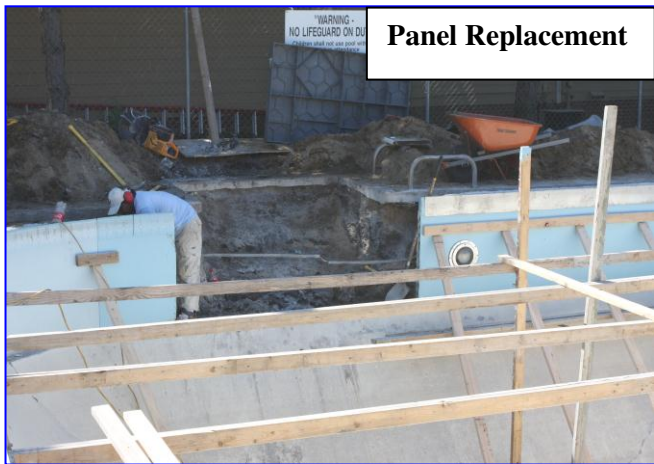
SAMPLE PICTORIAL SEQUENCE ON BACK OF THIS PAGE

Necessary with all panel wall pool renovations, bracing was initially set to keep structural integrity on the pool walls. New, rigid SCH 80 PVC plumbing was installed for this cold, outdoor climate with four skimmers. After coping removal and panel wall replacement, a band of 304 S/S was installed at the uppermost interior perimeter of the pool and attached to the panel walls. Frost-proof waterline tiling was added and a cantilevered, concrete

coping was poured *in situ* and topped with a colored, textured kool-deck topping. New concrete entry steps were added. The failed spray applied PVC vinyl membrane was completely removed. Following surface preparations, the INTER-GLASS® Reinforced Polymeric System was installed over the entire remaining pool interior surface.
